Patch Release Note

Patch 86241-08 For Rapier Switches and AR800 Modular Switching Routers

This patch release note lists the issues addressed and enhancements made in patch 86241-08 for Software Release 2.4.1 on existing models of Rapier L3 managed switches and AR800 Modular Switching Routers. Patch file details are listed in Table 1.

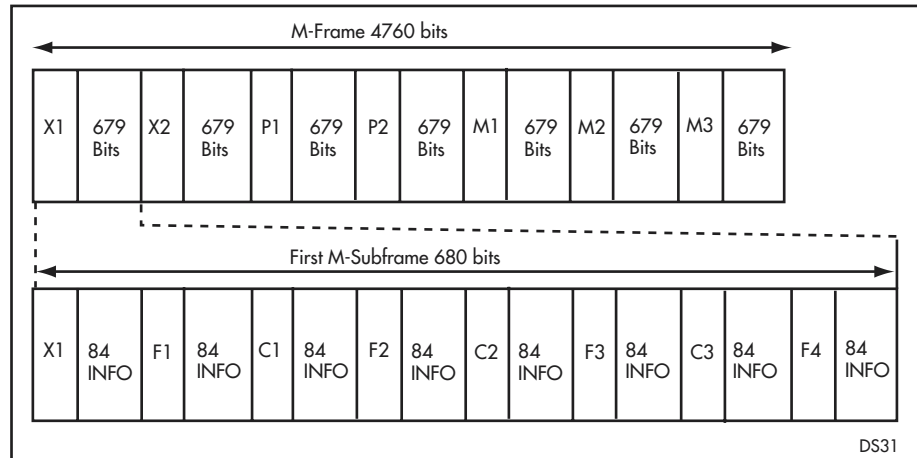
Figure 3: DS3 Framing Structure.

into 8 blocks of 85 bits with 84 bits available for payload, and one bit for framing overhead. The frame structure is shown in Figure 3 on page 40.

The switch with the DS3 interface is called the *near end*. The entity the switch connects to is called the *far end*. X1 and X2 are set to 1 if the near end is receiving an *Alarm Indication Signal* (AIS), a *Loss Of Frame* (LOF), or a *Loss Of Signal* (LOS). This allows the near end to indicate to the far end that it is experiencing a problem and is known as *Far End Receive Failure* (FERF).

P1 and P2 form the *P-bit channel*. They provide parity information for the preceding M-frame.

The three C-bits in M-subframe 4 are designated as FEBE bits. The FEBE bits are returned to the far end to indicate the occurrence of a framing error or CP-bit parity error. If none occur, the FEBE bits are set to all ones. One or all of the FEBE bits are set to zero if a CP-bit parity error or an error in the F or M bits is found.

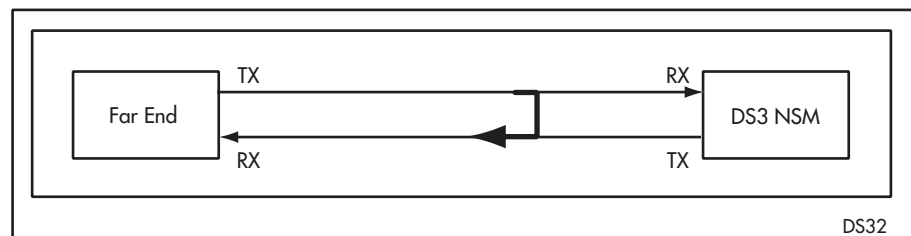
Figure 4: Line Loopback.

Line loopback is shown in Figure 4 on page 41. In this loopback mode the receive signal is looped straight to the transmit signal.

Payload loopback is similar to line loopback. The difference is that only the payload load is looped back from receive to transmit. The overhead is sourced from the DS3 NSM.

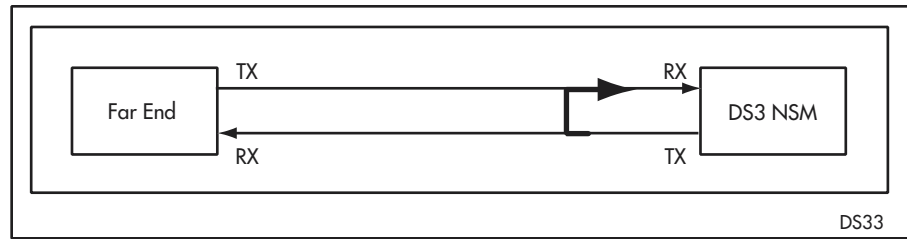
Figure 5: Diagnostic Loopback.

Diagnostic loopback is shown in Figure 5 on page 42. In this loopback mode the transmit signal is connected straight to the receive signal.

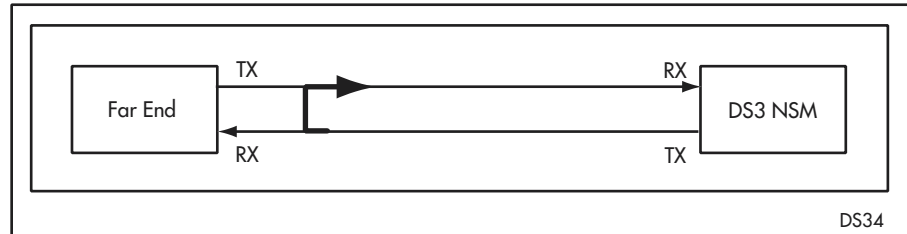
Figure 6: Remote Loopback.

In C-bit parity mode it is also possible for the switch to request a loopback at the far end. This is shown in Figure 6 on page 42. This is achieved using the FEAC channel. The switch can also respond to remote loopback requests via the FEAC channel. This results in a near end Line Loopback (see above).

Note that it is possible to configure near end local and remote loopbacks at the same time.
